**Failure Analysis, Cadmium Brush Plate Qualification and  
Salt Fog Testing of the AH-64 Shock Strut Mount,  
P/N 7-311113409**

**ARL-TR-2870**

**November 2002**

**Weapons and Materials Research Directorate, ARL**

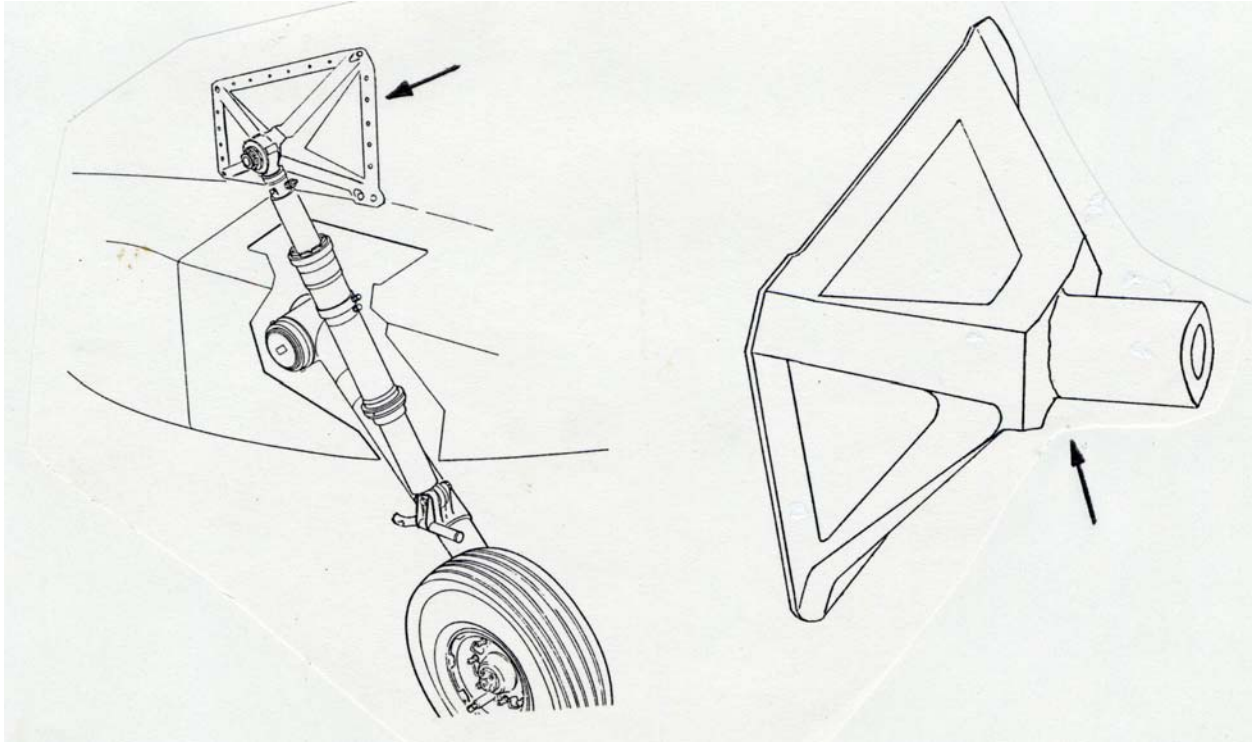
Figure 1. Schematic of the strut mount attached to the helicopter and the location of failure.

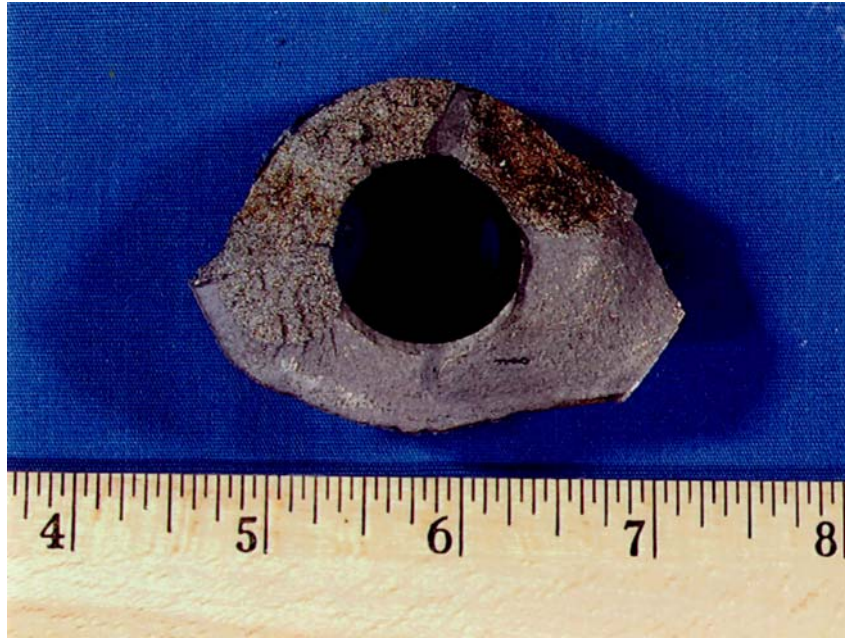
Figure 2 shows the fracture surface of the sectioned component in the as-received condition. The part failed at the machined radius of the spindle section. Figure 3 is a close-up of the fracture surface using oblique lighting, showing the fracture features, such as shear lips and beach marks. Two distinct cracks were noted and labeled “primary” and “secondary,” based upon the severity of corrosion on the fracture surface (the crack with the most severe corrosion was labeled primary, while the other was labeled secondary). These two crack fronts initially propagated on different planes and converged during fast fracture in the location shown in Figure 3. The size of the grains within these intergranular regions was so large that the resultant “rock candy” morphology was observed using light optical microscopy. Figures 4 and 5 show the intergranular morphology of the primary and secondary cracks, respectively. The green-colored primer was nonexistent along the length of the spindle, and the only evidence of the primer coating on the entire section was along the small portion of the shoulder shown in Figure 6. Visual evidence of the cadmium coating, as noted by white corrosion products, was only observed along the threads, as shown in Figure 7, and was not present anywhere else on the failed section. These coatings most likely wore off in service. The spindle itself showed areas of heavy corrosion and pitting. Figure 8 shows the radius adjacent to the primary origin. Note the corrosion pit that was only 0.031 in away from the fracture origin. Corrosion pits were also adjacent to the secondary origin, as shown in Figure 9. Corrosion pitting was prevalent along the spindle, and Figure 10 shows an example of a typical grouping of these pits within a corroded

Figure 2. Fracture surface of the failed part in the as-received condition (mag.  $\sim 1H$ ).

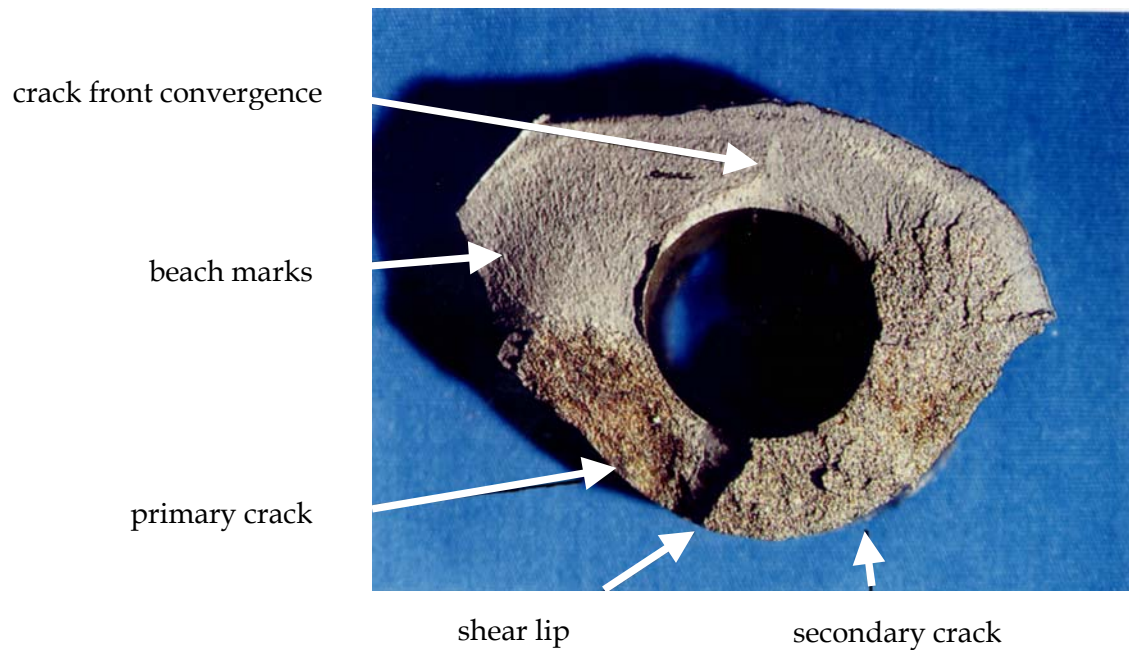
Figure 3. The fracture surface using oblique lighting. Note the shear lip separating the primary and secondary cracks, as well as the beach marks (mag.  $\sim 1.4H$ ).

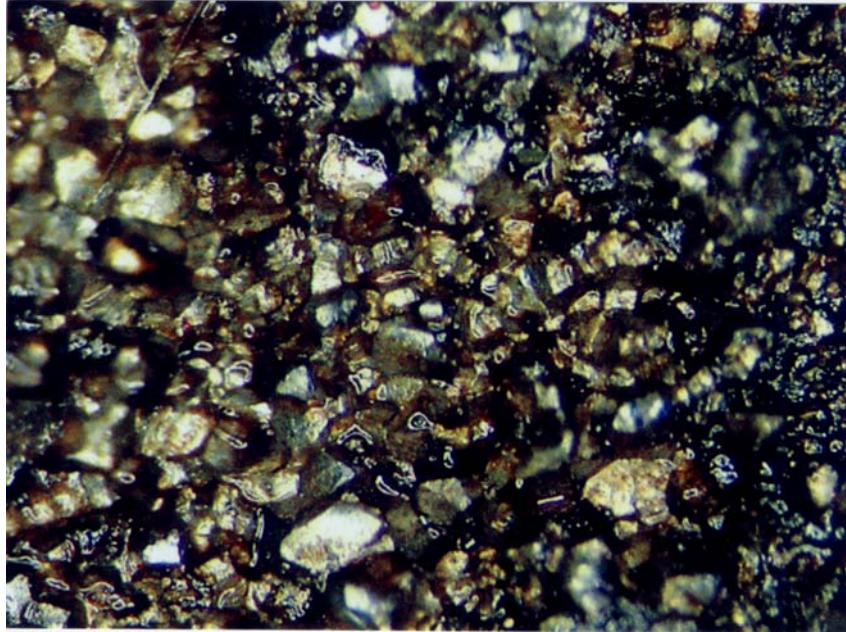
Figure 4. Intergranular morphology observed within primary crack using light optical microscopy (mag. 30H).

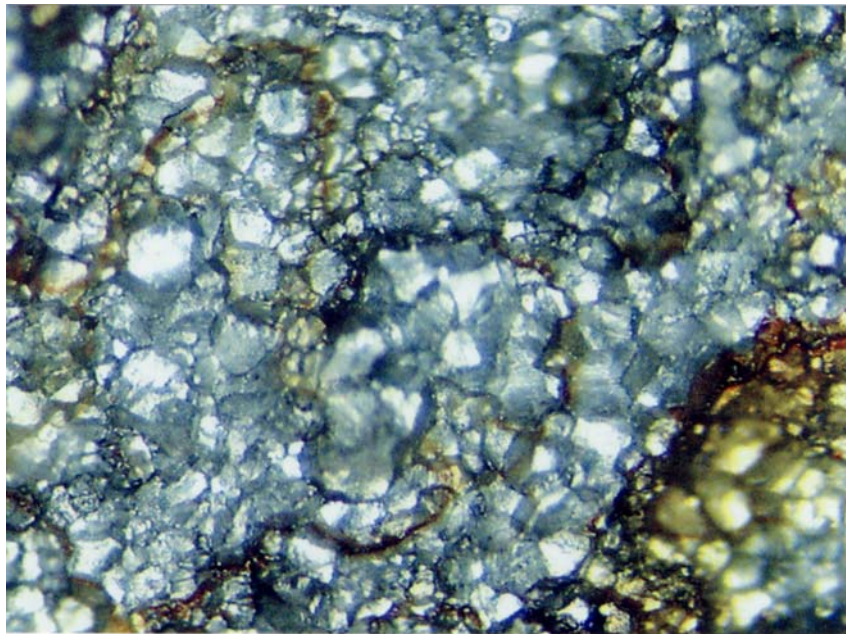
Figure 5. Intergranular morphology observed within secondary crack using light optical microscopy (mag. 30H).

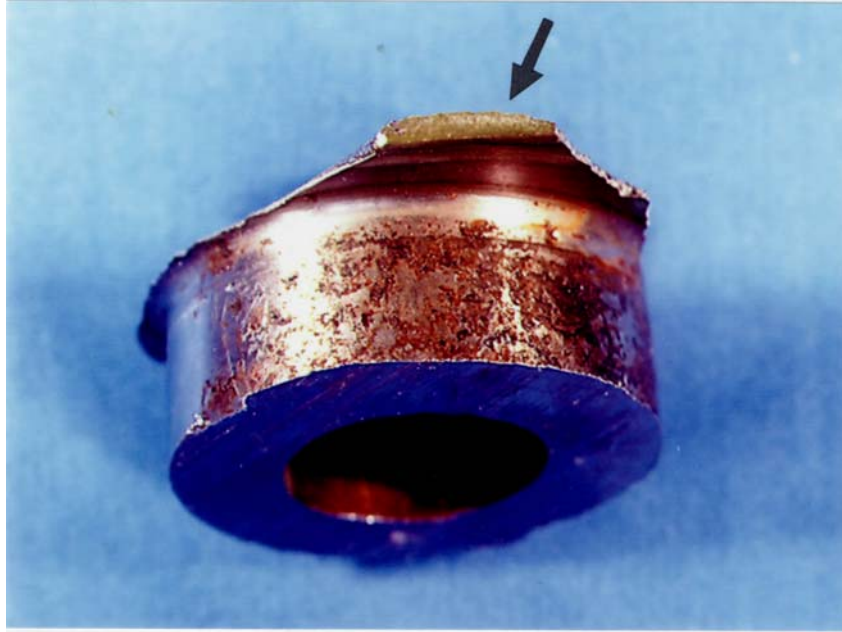
Figure 6. The only evidence of the green epoxy primer was along this small section of the shoulder.

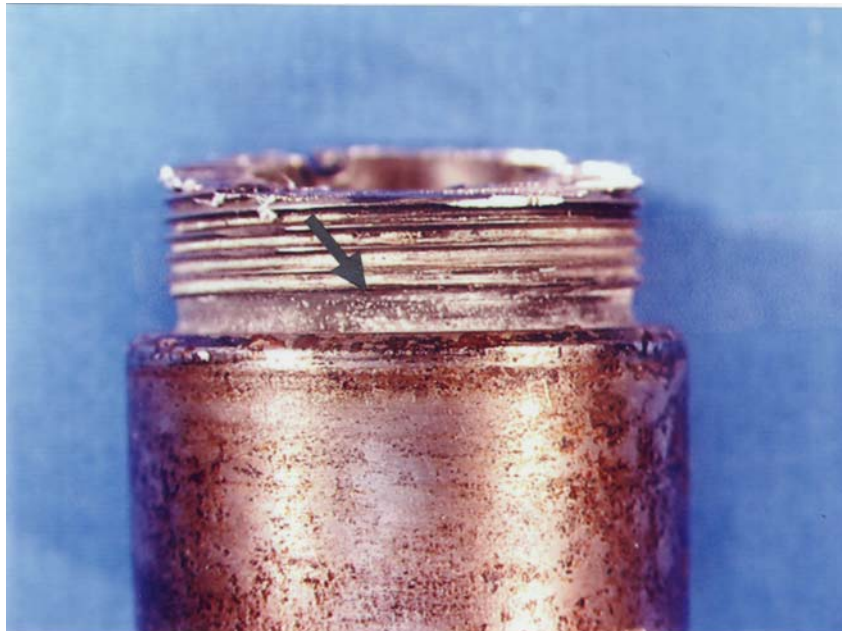
Figure 7. The only evidence of cadmium on the failed part was in the threads, shown here as a white, powdery corrosion product energy dispersive spectroscopy (energy dispersive spectroscopy [EDS] confirmed the presence of cadmium) (mag.  $\sim 1.5\times$ ).

- Cadmium Plating: Numerous shock strut mounts have failed in the same location. A common link to each failure is the fact that the cadmium coating along the spindle and radius is worn off and corroded away, leading to corrosive attack. The use of a dry film lubricant could reduce wear in these regions.

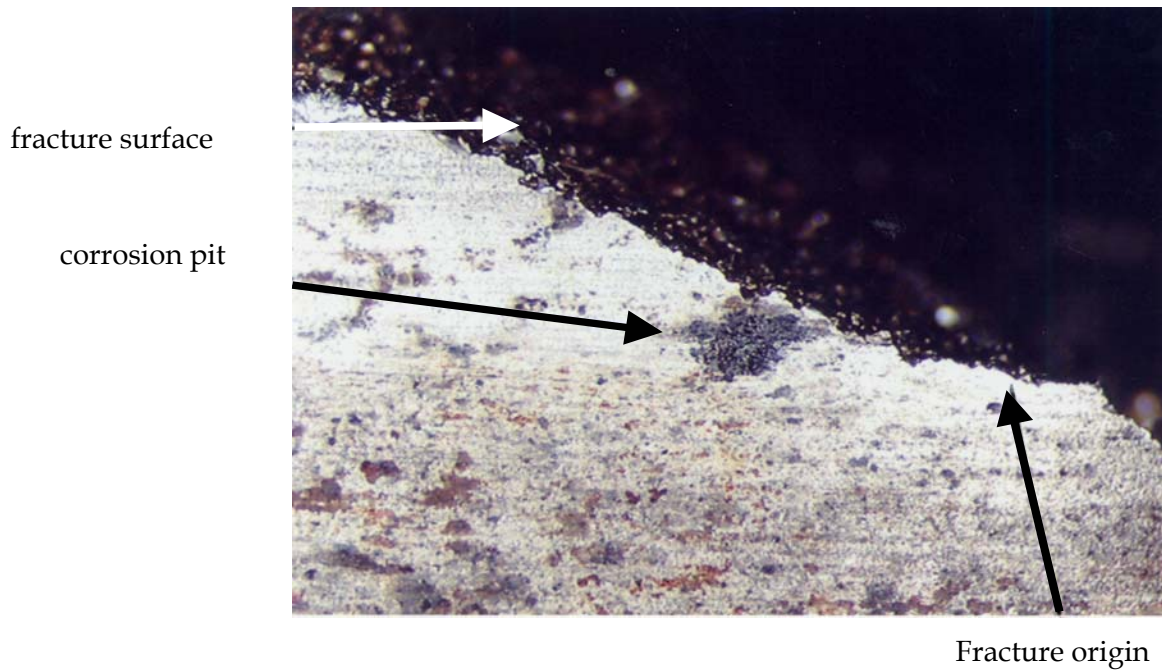
Figure 8. Corrosion pits adjacent to the primary origin (mag. 10H).

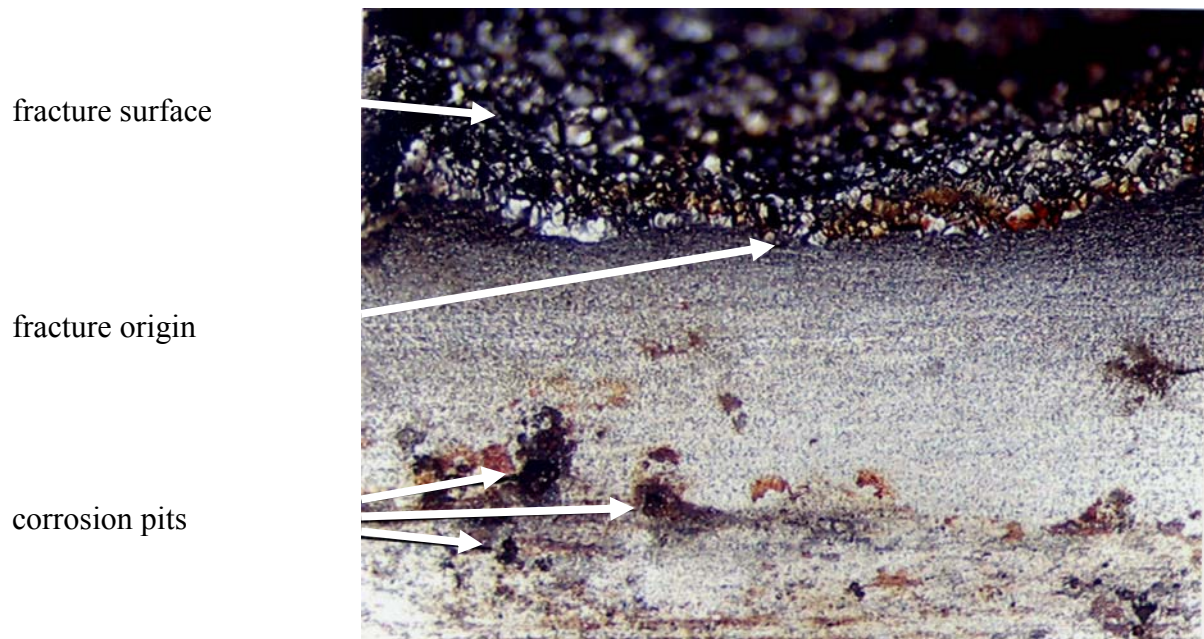
Figure 9. Corrosion pits adjacent to the secondary origin (mag. 10H).

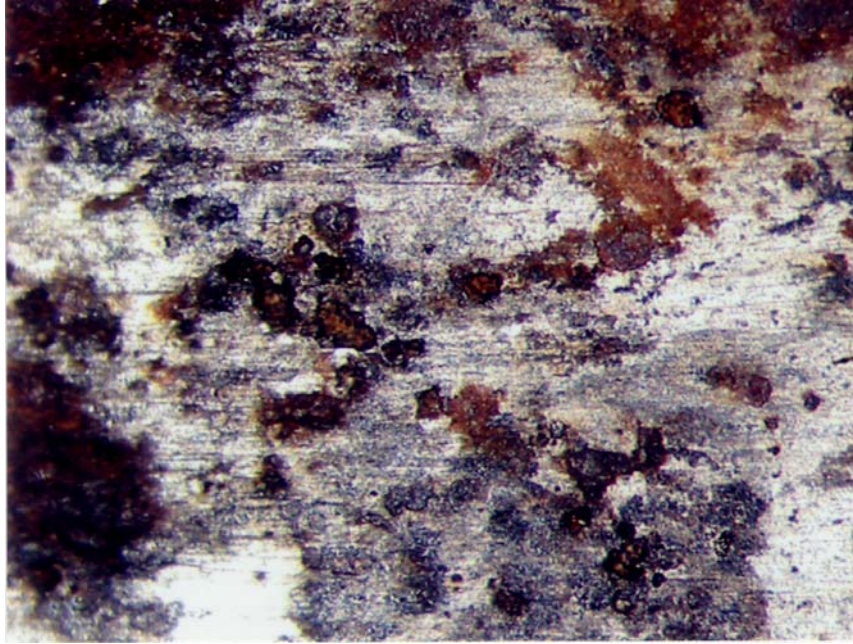
Figure 10. Group of pits observed along the spindle of the failed part. Pitting was prevalent along the spindle region (mag. 25H).

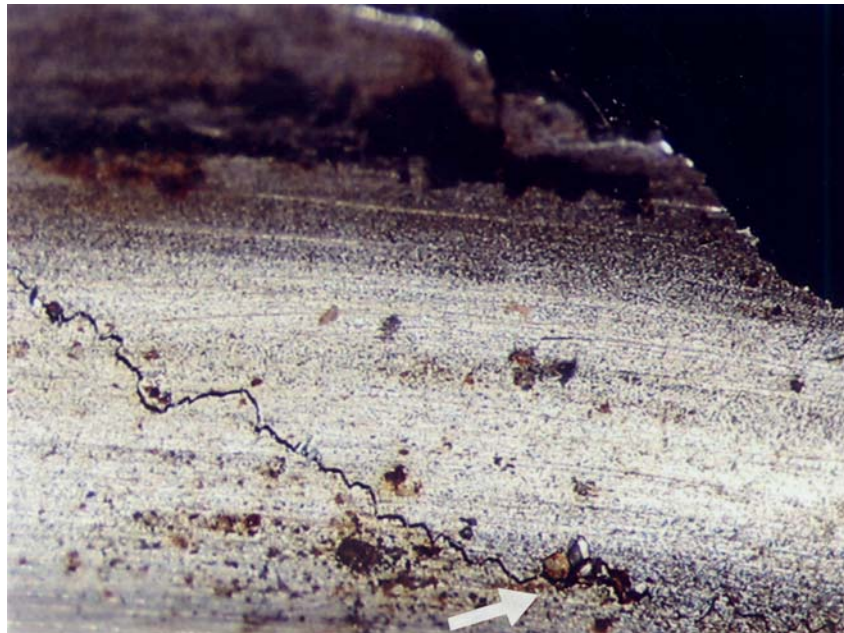
region. Also observed was a competing crack that was adjacent to the primary origin. Figure 11 shows the intergranular nature of this crack. There was also evidence of intergranular attack along this crack path. It was difficult to discern the exact location of the fracture origins; however, based upon the heavy corrosion in certain areas on both the primary and secondary crack surfaces, the general location of the origins was surmised.

Figure 11. Competing crack path adjacent to primary fracture surface. Note the intergranular nature of the crack, as well as the region of intergranular attack (mag. 15H).

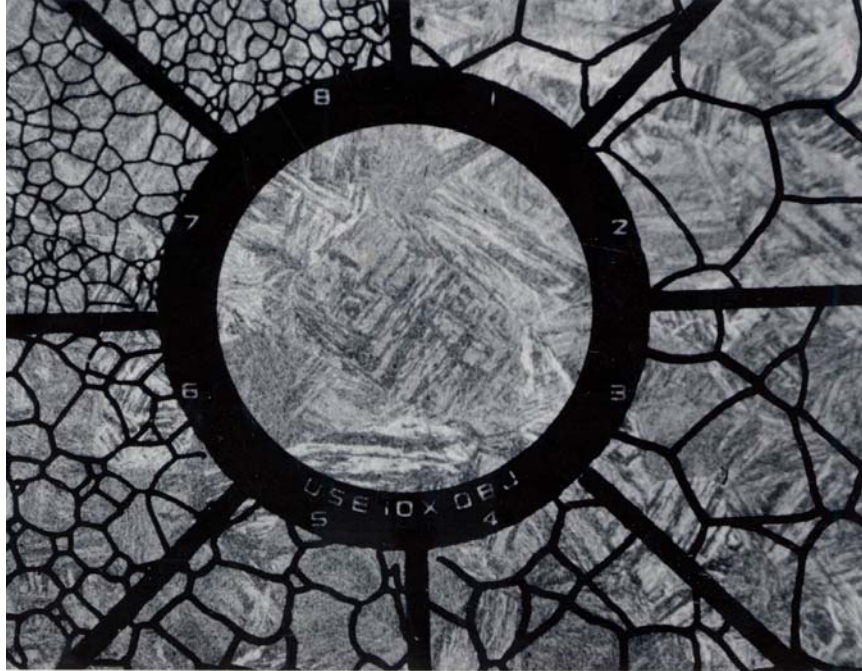
between nos. 2 and 3 at 100H magnification using the ASTM E112 charts over Figure 12. To verify this, a photomicrograph was taken using a grain size reticle, as shown in Figure 14. Again, the size was between nos. 2 and 3. The ASTM E112 charts indicate that the nominal diameter of the average grain is between 0.005 and 0.007 in, respectively for a grain size of nos. 3 and 2. A photomicrograph was subsequently taken of this structure at 100H, using an incremented reticle (Figure 15). As shown, the grain appear to have diameters ranging from 0.005–0.01 in, which correlated to the previous measurements. Subsequently, the intergranular fracture surface shown in Figure 18 (also see section 2.8) was also examined for grain size using the ASTM E112 “Fracture Grain Size” method. This technique is typically used for high-hardness, brittle steels with a predominantly martensitic structure, such as tool steels, high-carbon steels and martensitic stainless steels, and should be done with the specimen in the as-quenched or lightly tempered condition. Even though the Maraging 300 steel is a low-carbon alloy, the results obtained compared favorably to those from the other three methods. From Figure 18, the grain size ranged from ~100–200  $\mu\text{m}$ , which correlated to a range of 0.004–0.008 in.

Figure 14. Microstructure of the material with grain size reticle overlay. The grain measured between nos. 2 and 3. Marble's Reagent (mag. 100H).

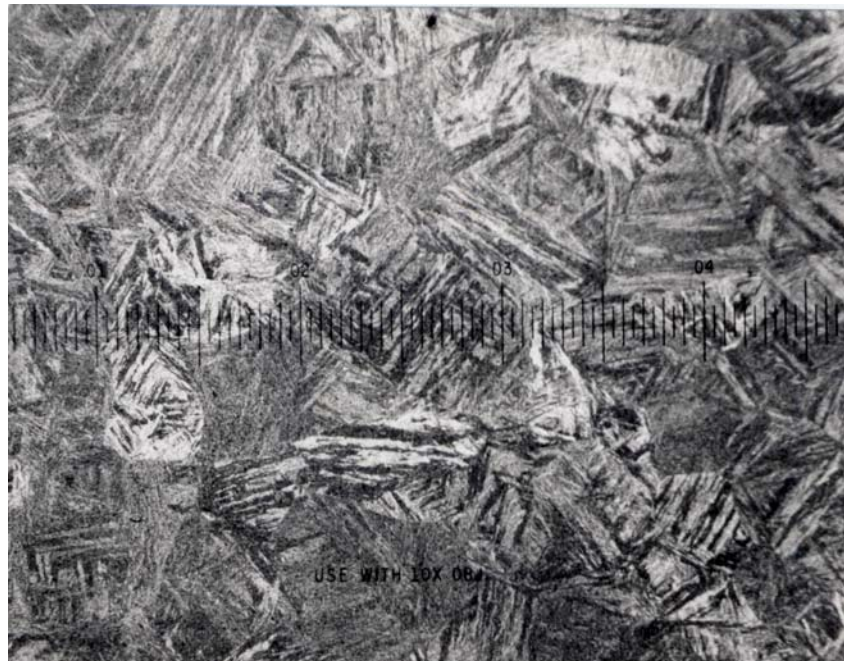
Figure 15. Microstructure of the material with incremented reticle overlay. The grain size measured between 0.005 and 0.01 in. Marble's Reagent (mag. 100H).

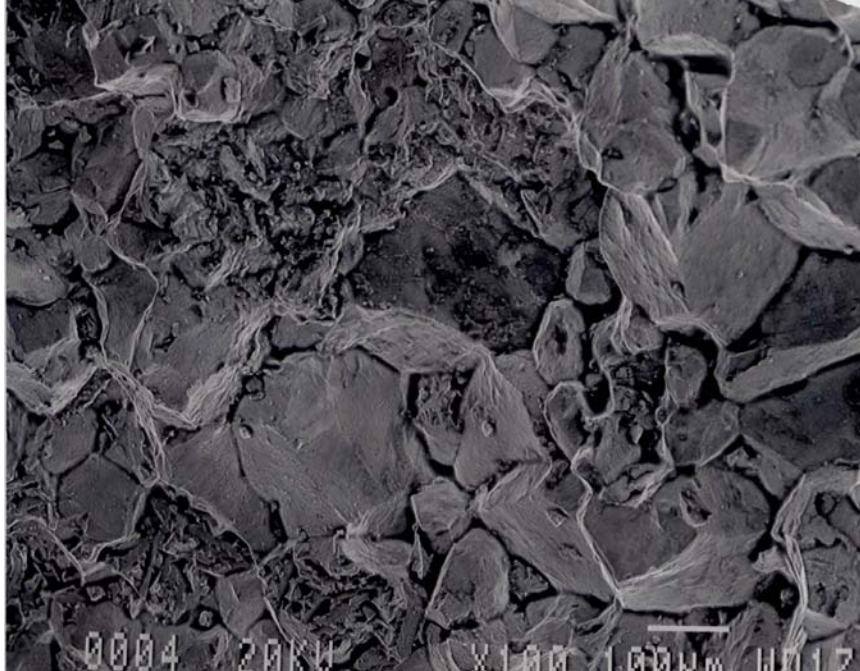
morphology of the both the primary crack and the secondary crack was intergranular, as shown in Figures 17 and 18. Note the textbook “rock candy” morphology and the secondary cracking typical of a brittle fracture. Figure 19 (taken within the secondary crack fracture surface) shows this morphology at increased magnification. Note the evidence of micro-pores, which are typical of 18% nickel maraging steel hydrogen-assisted failures [5]. These two crack fronts were separated by a shear lip, which failed in a ductile manner, as evidenced by the morphology shown in Figure 20. Figure 21 shows the transition zone between the secondary crack and the adjacent shear lip that separated the two crack fronts. Figure 22 shows the transition zone between the primary crack and the transgranular/overload morphology. This was also typical of the transition zone between the secondary crack and the transgranular/overload region. Figures 23 and 24 show the transgranular/overload morphology that made up ~45% of the fracture surface. Figure 25 shows this morphology at higher magnification. As shown, this surface morphology represents very low cycle fatigue, in which the loading produces not only the transgranular morphology typical of fatigue, but also ductile dimples indicative of tensile overload. No fatigue striations were discernible within the transgranular/overload regions. An attempt was made to examine the fracture origins; however, the corrosion, as well as the nature of brittle failures, made it difficult to pinpoint the exact sites with 100% accuracy.

Figure 17. Morphology of the primary fracture surface. "Rock candy" was prevalent within this region (mag. 100H).

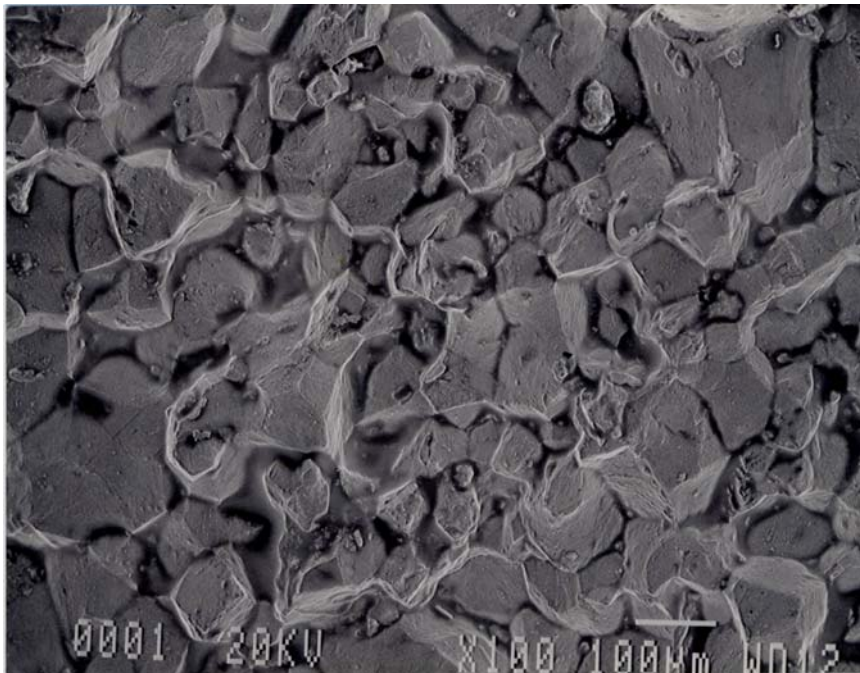
Figure 18. Morphology of the secondary fracture surface. "Rock candy" was prevalent within this region (mag. 100H).

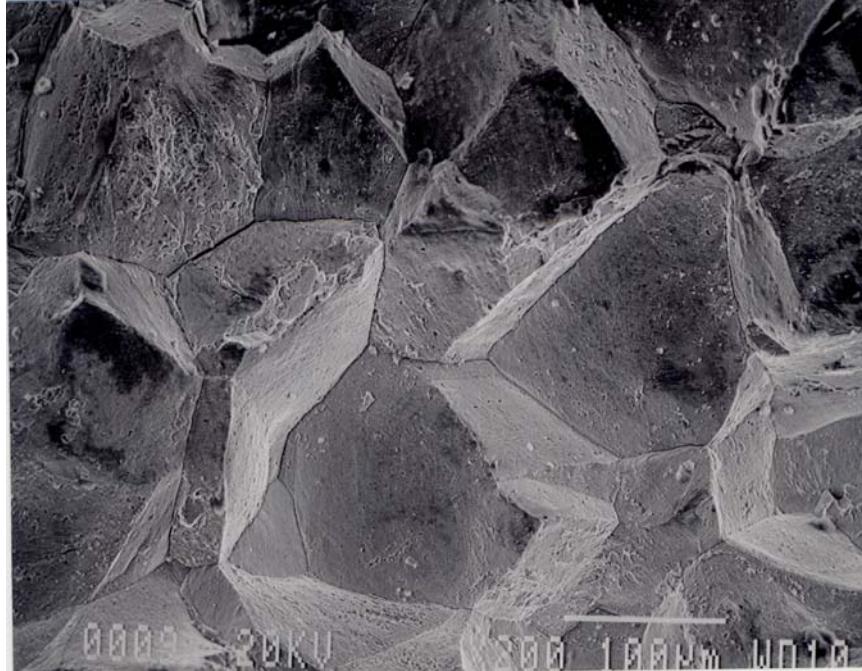
Figure 19. Magnified view of the intergranular morphology showing secondary cracking (mag. 200H).

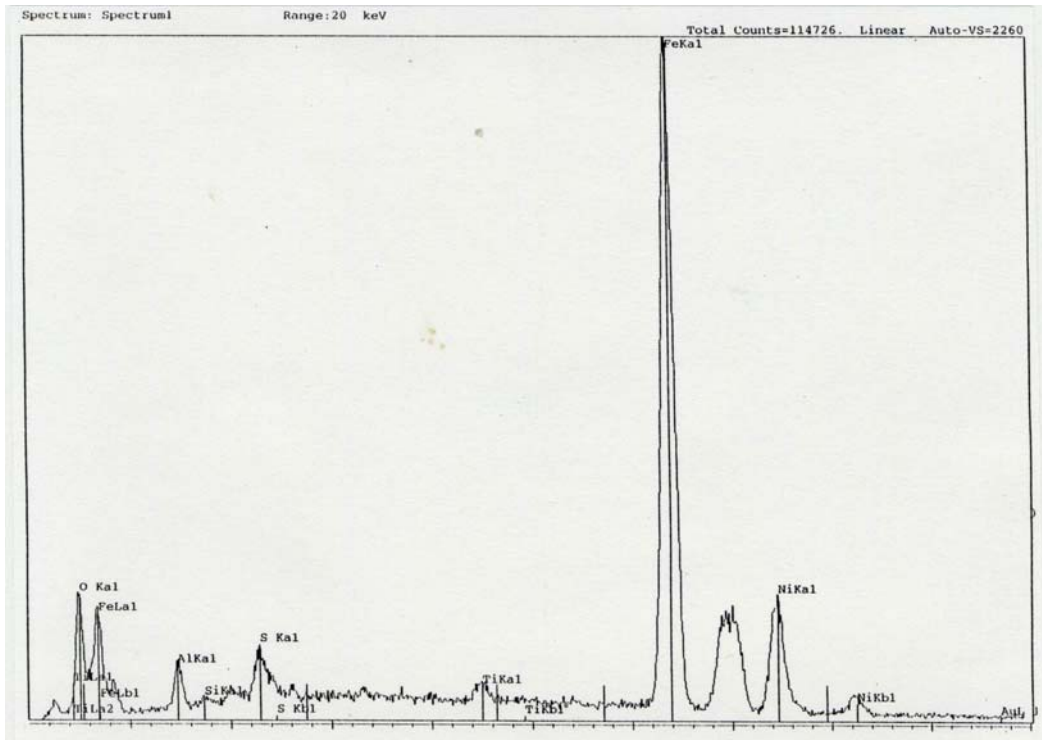
Figure 26. Representative EDS spectra of the spindle of the failed part. No evidence of cadmium was noted along the spindle.

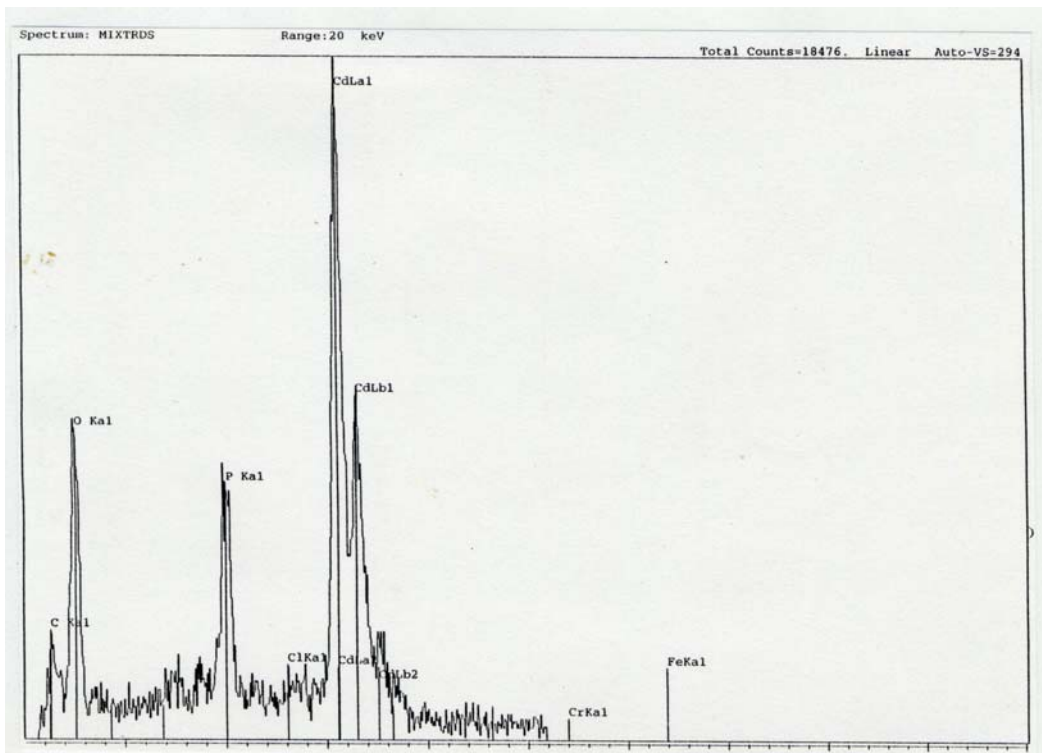
Figure 27. Representative EDS spectra within the threads of the failed part. Cadmium was noted within the threads.

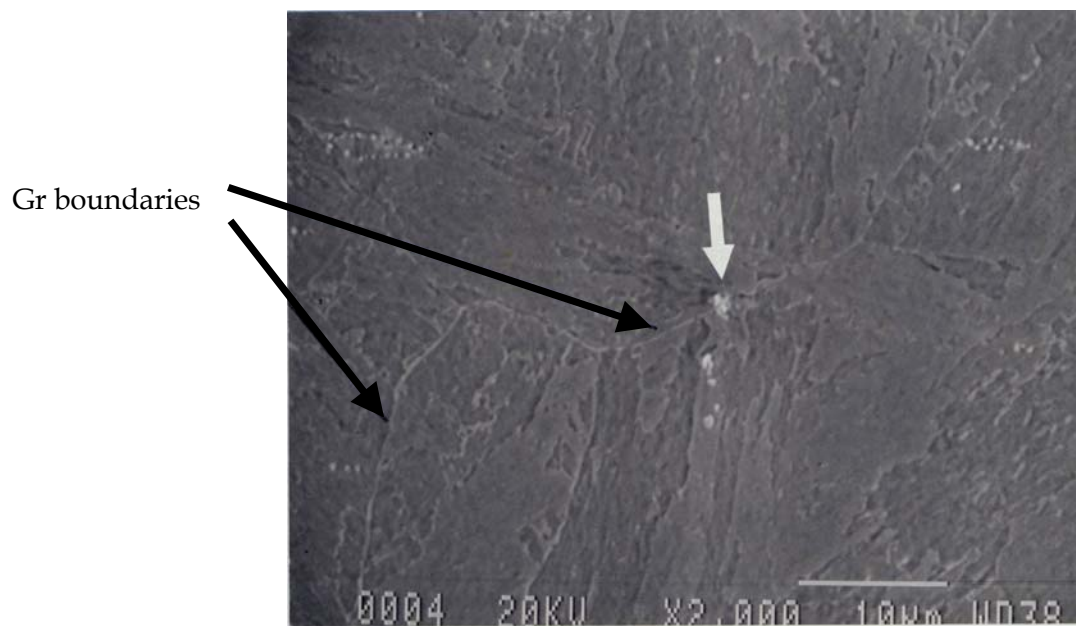
Figure 28. SEM micrograph of polished and etched surface showing titanium precipitate (white arrow) within a grain boundary that was subjected to EDS (mag. 2000H).

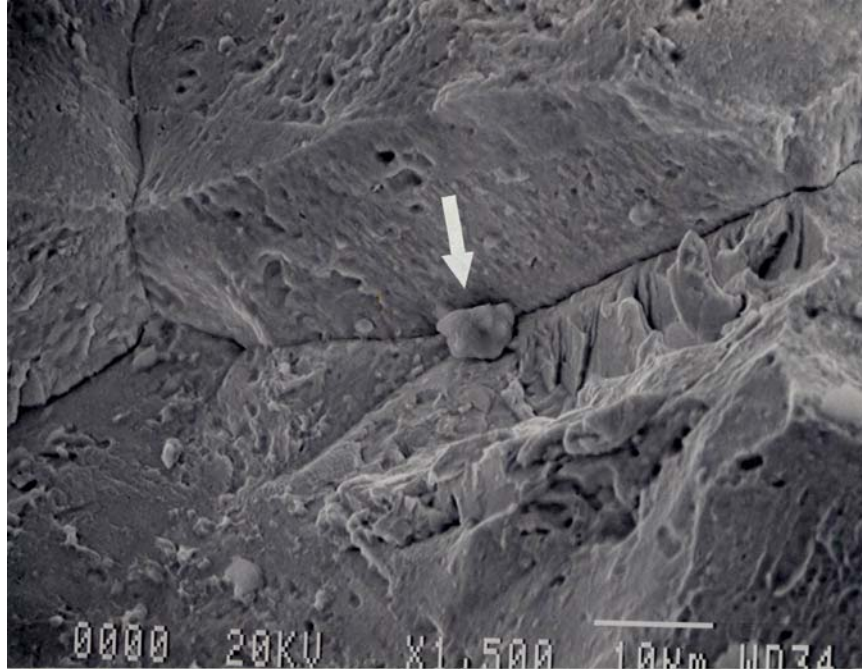
Figure 30. SEM micrograph of intergranular morphology of the primary fracture, showing the titanium-carbonitride precipitate that was examined using EDS (Figure 31) (mag. 1500H).

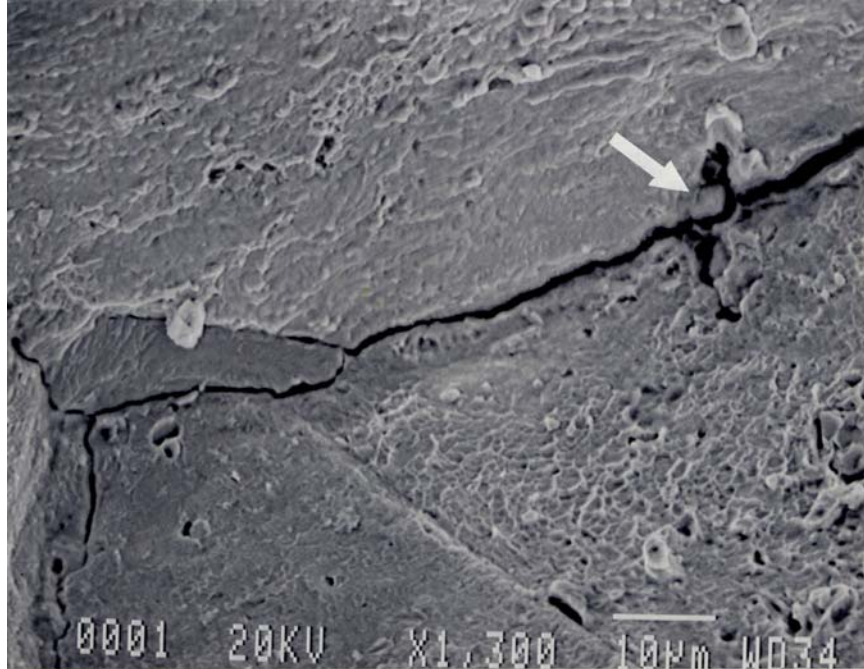
Figure 32. SEM micrograph of intergranular morphology of the primary fracture, showing another titanium-carbonitride precipitate (mag. 1300H).

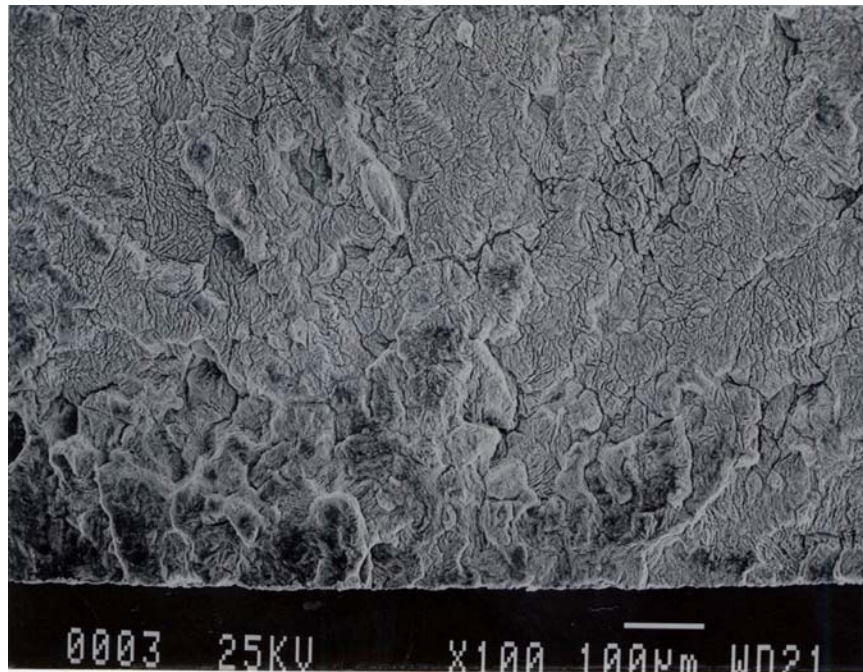
Figure C-12. Intergranular attack noted at origin no. 1 of Ft. Lewis specimen no. 3 (mag. 100H).

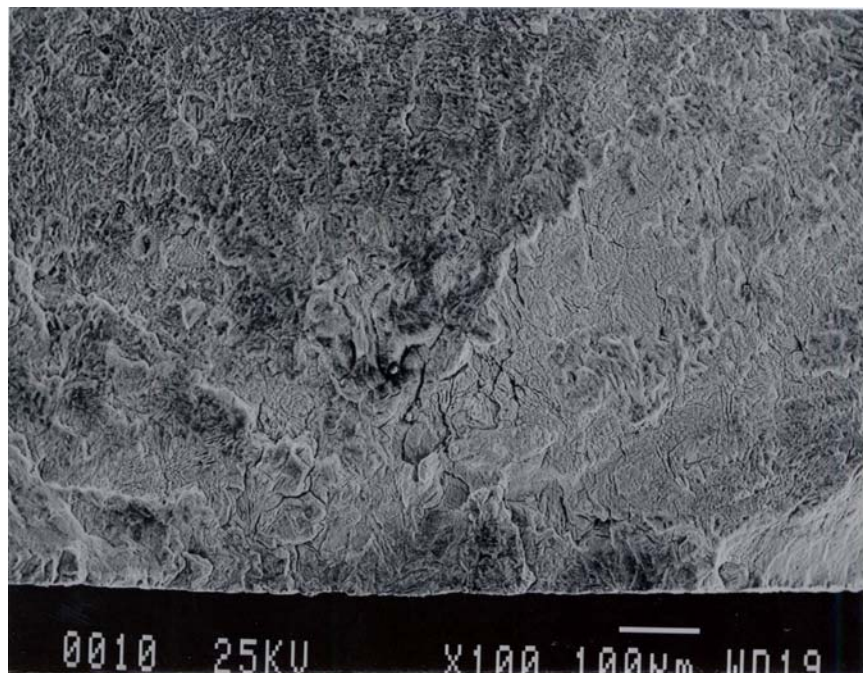
Figure C-13. Intergranular attack noted at origin no. 2 of Ft. Lewis specimen no. 3 (mag. 100H).

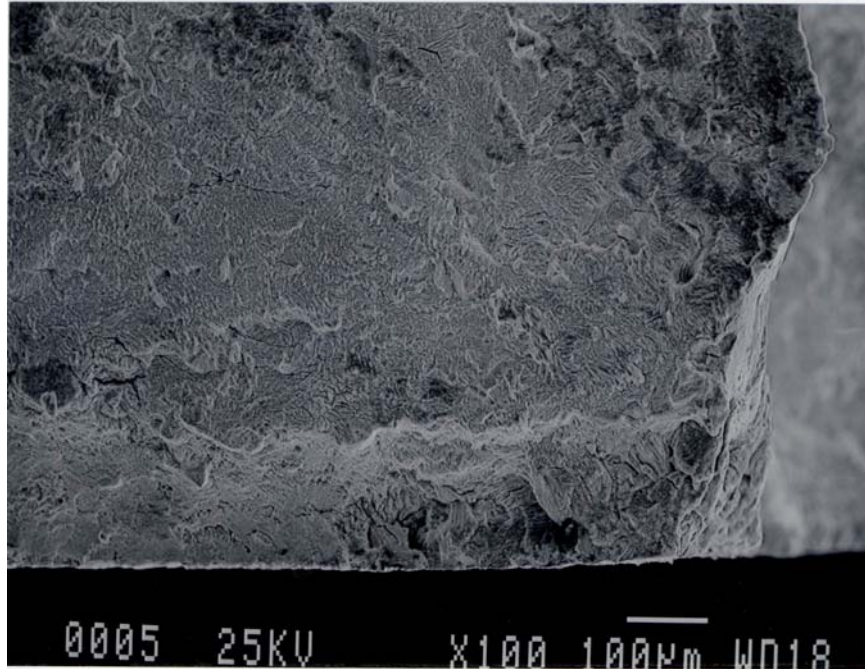
Figure C-14. Intergranular attack noted at origin no. 3 of Ft. Lewis specimen no. 3 (mag. 200H).
